*Review paper*  
*UDC 625.11:656.222.4.01*  
*DOI: 10.7251/afts.2018.1018.009D*  
*COBISS.RS-ID 7322648*

## RESEARCH METHODOLOGY OF RAILWAY ROUTE DOBOJ – ZENICA, SECTION km 103+500 – MAGLAJ

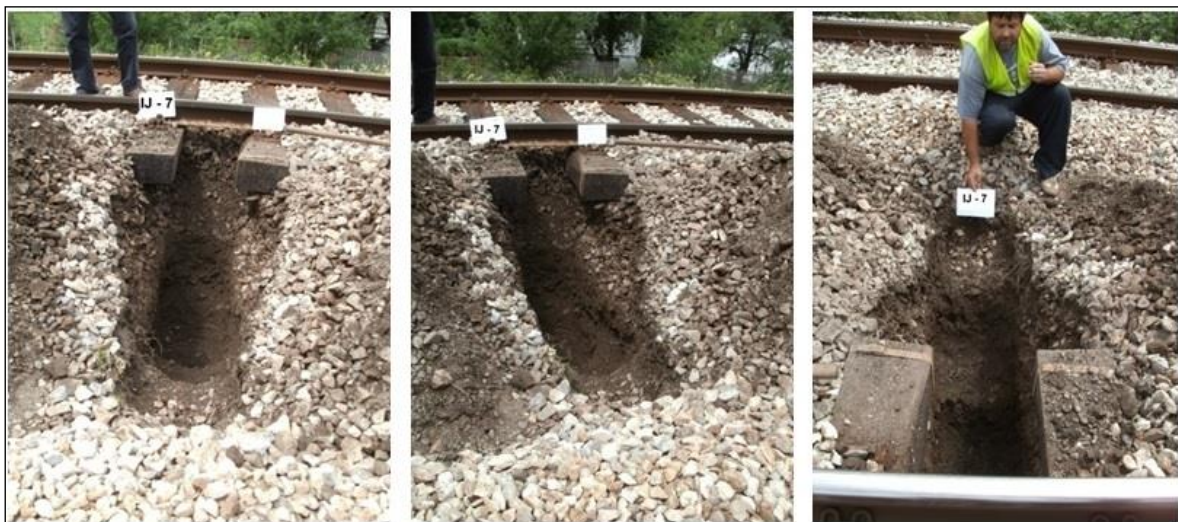
Figure 2a. Characteristic example of trench IJ – 7 on chainage km 105+450,00

Trenches were in detail mapped, photographed, figure 2a, and also were taken disturbed and undisturbed samples covered with the same material. Based on terrain mapping, results of laboratory tests, profiles of all trenches were made, figure 2b, as well as transverse profiles of the terrain along the route of the railroad.

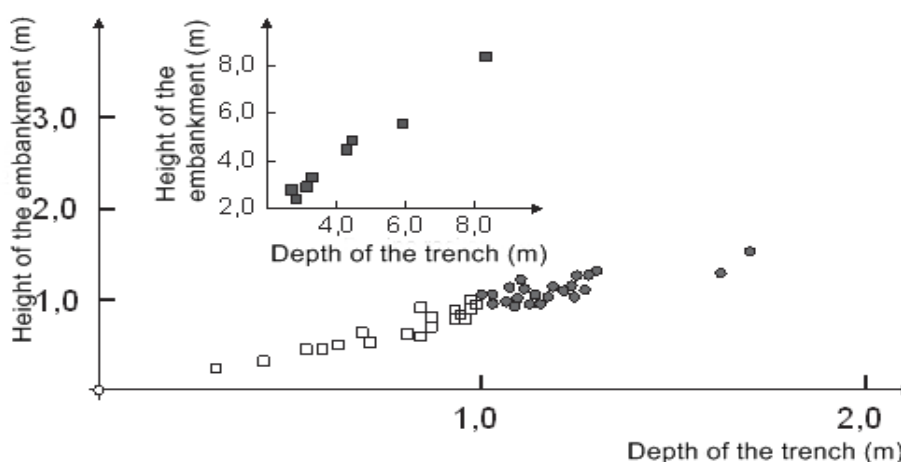
Figure 3. Chart of relations of height of embankment and depth of trenches along the railroad

Exploratory trenches were carried out along the entire route mostly at a depth of 0.7 – 1.5 m, figure 3. If we keep in mind that the depth of the trench was 0.2 - 0.3 m below the embankment, it can be concluded that the embankment thickness is ranging from 0.5 – 1.2 m. It is important to emphasize that the right track on the same chainages is characterized by deeper embankment, because the regulations from 1978, were more demanding.

Experiment values  $E_{vd}$  determined in trenches by depth during their manufacture, are different in a wide range from  $< 10$  to  $> 100 \text{ MN/m}^2$ . It is characteristic to note that deeper parts of the embankment are worse and are related to the chainage that are singled out as those of poor quality according to certain characteristics, primarily disordered circumferential channels.
