## LANDSLIDES ON THE ROADS OF THE NORTHERN PART OF THE REPUBLIC OF SRPSKA AS A RESULT OF ELEMENTAL OR ANTHROPOGENIC PROCESSES

Đurić Neđo,<sup>1</sup> Đurić Dijana<sup>2</sup><sup>1</sup>Technical Institute Bijeljina, Starine Novaka street nm, Republic of Srpska, Bosnia and Herzegovina, e.mail, nedjo@tehnicki-institut.com<sup>2</sup>Faculty of Civil Engineering Subotica, Univercity of Novi Sad, Serbia

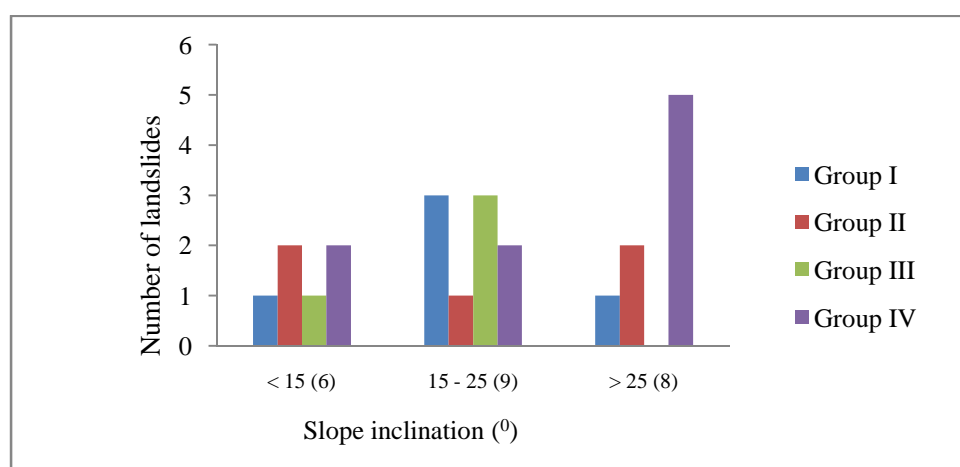
23 characteristic landslides were analyzed and classified into four groups according to their area of origin. Each landslide is marked with a number from 1 - 23, and their spatial position is shown in figure 1. Surveyed by the selected groups from I - IV, the slope inclinations on which the landslides formed values from 9,2 - 28,4°, table 1. Selected landslides are divided into three categories, where it can be seen that the landslides are more present on slopes with higher inclinations. They classify to the second and third category with inclinations from 15 -25° and > 25°, figure 3.

Figure 3. Landslide chart according to inclination of slopes by selected groups I - IV

The slope inclinations at the locations of the explored landslides range from 9,2 - 28,7° and they are classified into three categories, figure 3. Observed by the locations of selected landslide groups from I

- IV, the highest number of landslides occur at the slope with inclination of  $> 20^{\circ}$  in group IV. The terrain in this area is morphologically very developed and belongs to the mountainous part. In general, the analyzed landslides are related to slope inclinations that are often found in the literature data.

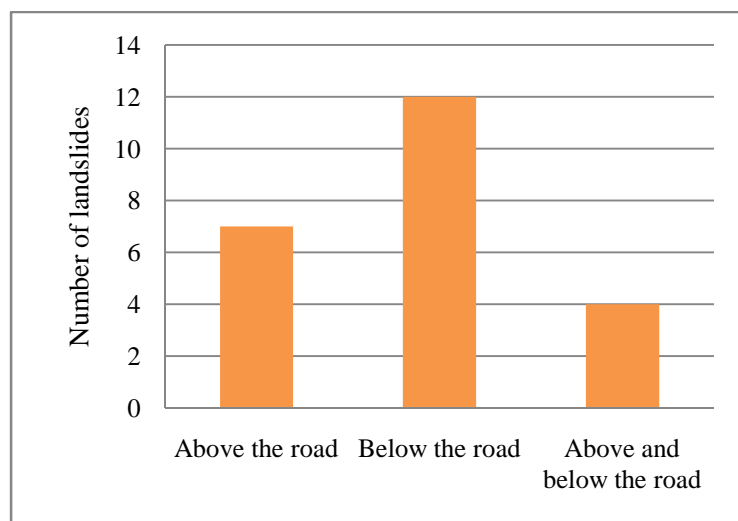
The formation of landslides on the roads is different from the fact that they occurred above the road, below the road, and one section of landslide cut the road completely because they were formed above and below the road, figure 4. By examining the above mentioned landslides, it was found that there was insufficient level of terrain exploration along the road route, especially in the part of conditionally stable or unstable zones.

Figure 4. Spatial position of landslides on the roads

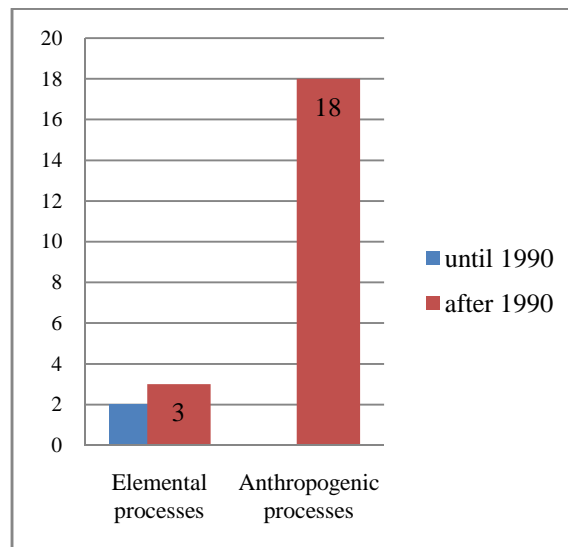
By the inspection of the periods of engineering activities on the roads, two periods were selected, until 1990 and after 1990 figure 5, which coincides with the period of change in the social system in this region.

Figure 5. Overview of landslides on the roads constructed before and after 1990

The basic findings during the examination of the selected landslides are that the roads constructed before 1990 are less damaged, not only during the May rainfall in 2014 and 2015, but during the entire period of their exploitation. The roads constructed after 1990 are almost all damaged with different degrees of damage along the road route. The reasons are familiar. The construction of roads before 1990 was in accordance with the applicable regulations at that time that required a higher degree of research, prior to the development of project documentation. Thereby, the project documentation was harmonized with the characteristics of terrain and the obligation of slope reconstruction during the construction of the road, and monitoring of the slope behavior during the exploitation of the road.

Roads constructed after 1990 include a period of rapid construction, which we have named here as "the modern construction". It is the construction of facilities without sufficient previous geological and engineering-geological research of the terrain, and in improving the quality of existing roads, often without project documentation, but it is all done during the phase of construction works [10]. The results of such a way of constructing are the damages of roads after heavy precipitation or winter time after snow melting. The May precipitation, which in 2014 and 2015 were the highest in that period, highest recorded since the meteorological observations in this area took place, in a few days, damaged almost all roads that were constructed on the principle of "modern construction".

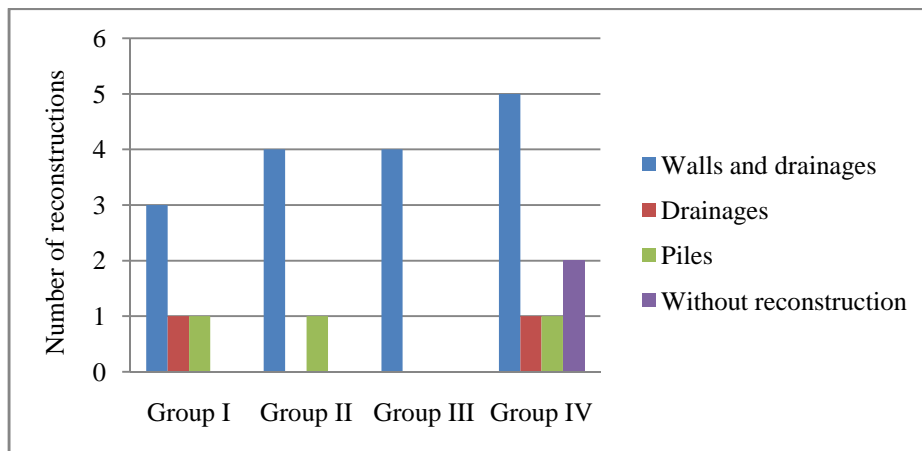
At the same time, with the inspection of the landslide characteristics, the slope reconstruction is also considered at the time of construction, that is, the condition of the restoration facilities after the occurrence of landslide. The slopes have been repaired by means of retaining walls, drainages, rarely with piles or by combination of mentioned objects, figure 6. All types of repairs are damaged,

especially retaining walls and piles. The construction of some retaining walls is not damaged, but it is moved together with the rock mass. It is evident that they were not founded deep enough in the hard formation rock, but instead they remained in the surface area. Some landslides had even earlier damages that were repaired, and now damaged again, so that various types of reconstructions can be observed at different periods of time. Usually these are retaining walls or walls and piles.

Figure 6. Overview of the types of reconstruction of slopes by selected groups I - IV

By review of damaged reconstructions on the roads conducted at the time of their construction and available project documentation, it is noted that reconstructions have not been appropriately conducted

in accordance with the projects, and projects in accordance with the geological-geomechanical characteristics of the terrain. The construction of retaining walls that were undamaged and moved by the rock mass show that they were not based in the hard rock [35,52,53,54,55,56,57,58]. They were appropriately conducted in a constructive sense, but there was no good binding with the hard rock. Drainages were not maintained over time, so that the revision shafts for collecting and draining water, as well as the drainage canals are neglected, which kept the water in the rock mass, deteriorated its structure and influenced the change in the tension condition and conditional balance.

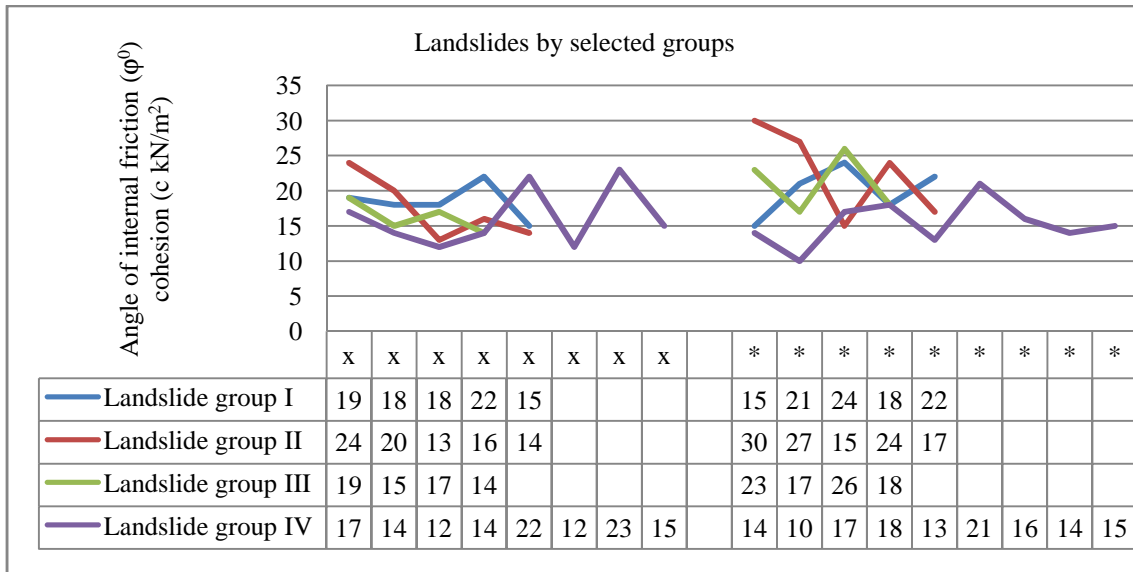
Figure 7. Values of the angle of internal friction ( $\phi$ ) and cohesion ( $c$ ) by selected landslide groups  
x. angle of internal friction, \*. cohesion

The common characteristic for landslides from Table 1 is as follows: from group I - III the angle of internal friction is balanced as opposed to cohesion, while for group IV both parameters have large oscillations from the landslide to landslide, figure 7. The reason is a complex geological structure due to the structural tectonic influences, which are also important for creating the surface covering of the terrain in which the landslides occurred. Majeвица as a mountain where the landslides of group IV are categorized is considered to have the most complex terrain structure in this area.

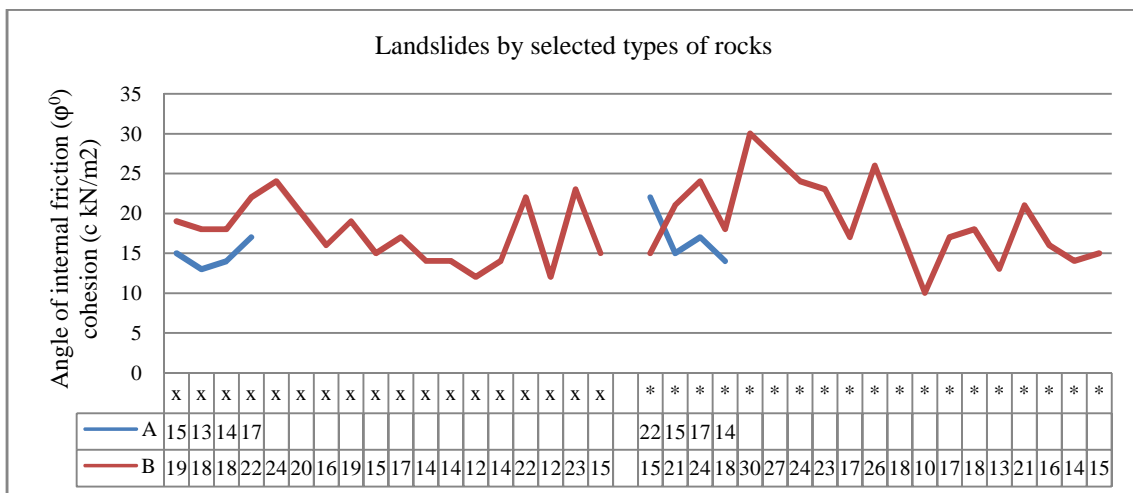
Figure 8. Values of the angle of internal friction ( $\phi$ ) and cohesion ( $c$ ) by selected types of rocks  
A. quasi-homogeneous rocks, D. heterogeneous rocks, x. angle of internal friction, \*. cohesion

More detailed observation of the parameters of resistance according to the type of rock in all groups of landslides is shown in figure 8. It refers to heterogeneous rocks, according to the larger number of samples. The oscillations of the parameters from landslide to landslide show the heterogeneity of the rocks in a wider range, which requires a higher degree of research when examining each landslide.

The values of the shear resistance parameters are favorable for the selected rocks of A and B, where in natural conditions there is no deterioration of the balance state. The balance is deteriorated at the contact of the quasi-homogeneous rocks A and the heterogeneous rocks B, which are under the influence of water and tend to move, especially in conditions of increased water quantity, their contact with water-impermeable rocks or by deterioration of the overall natural balance due to engineering activities in the field. Delimitation between quasi-homogeneous and heterogeneous rocks on some terrains is difficult to determine as clay rocks are sometimes more sandy, which makes them heterogeneous within that package.
