Review paper

LANDSLIDE REMEDIATION ON LOCATION ČOLE, THE SETTLEMENT ŽELJEZNO POLJE, ŽEPČE MUNICIPALITY

Talić Zlatan¹, Cerić Dženita², Rekić Ajla², Hrnjica Anela²

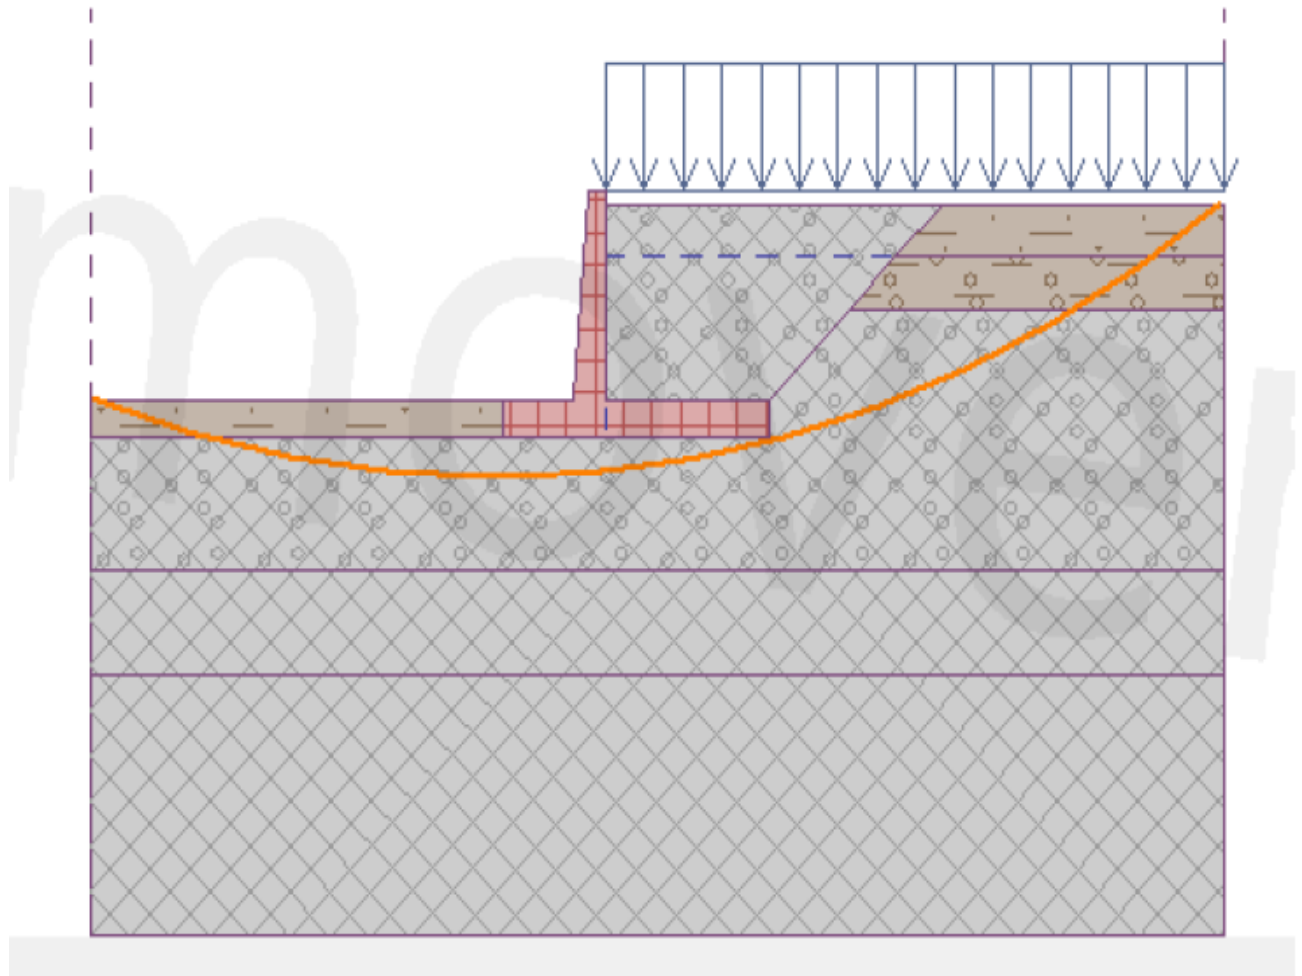
An analysis of the remediated slope was performed using the Spencer method and the utilization rate was 21.2 %. Figure 1 shows the most critical sliding surface of the repaired slope [3].

Figure 1. Calculation of slopes stability for repaired condition [3]

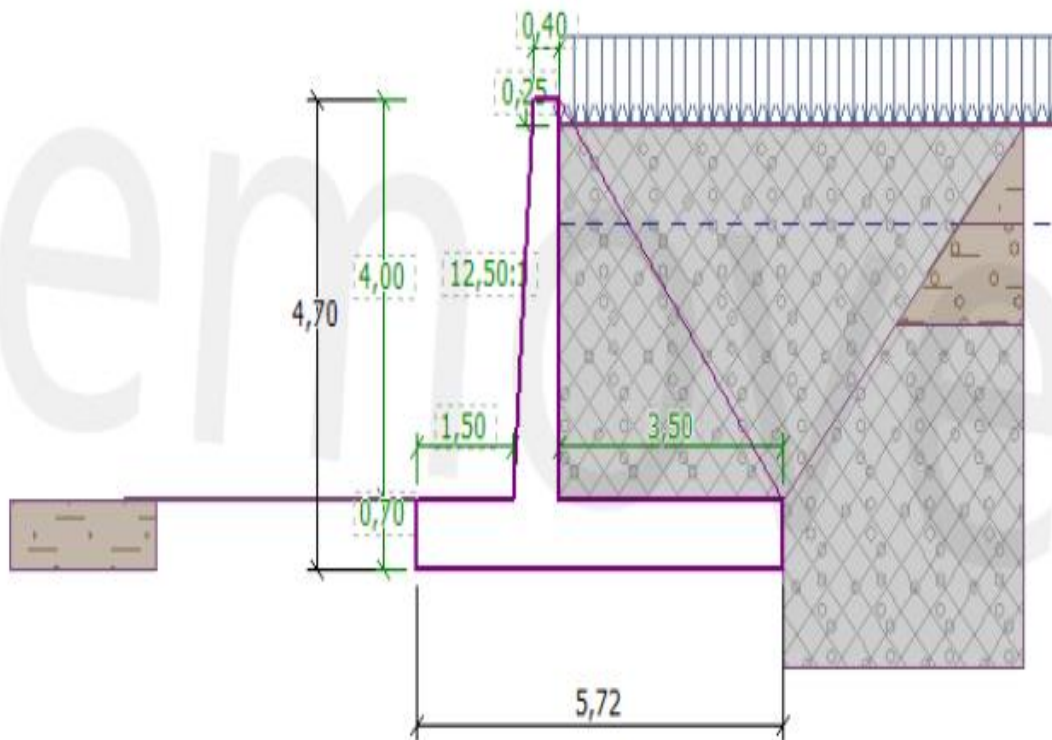
Figure 2. The dimensions of the retaining wall [3]

The dimensions of the retaining wall are given in Figure 2. [3]

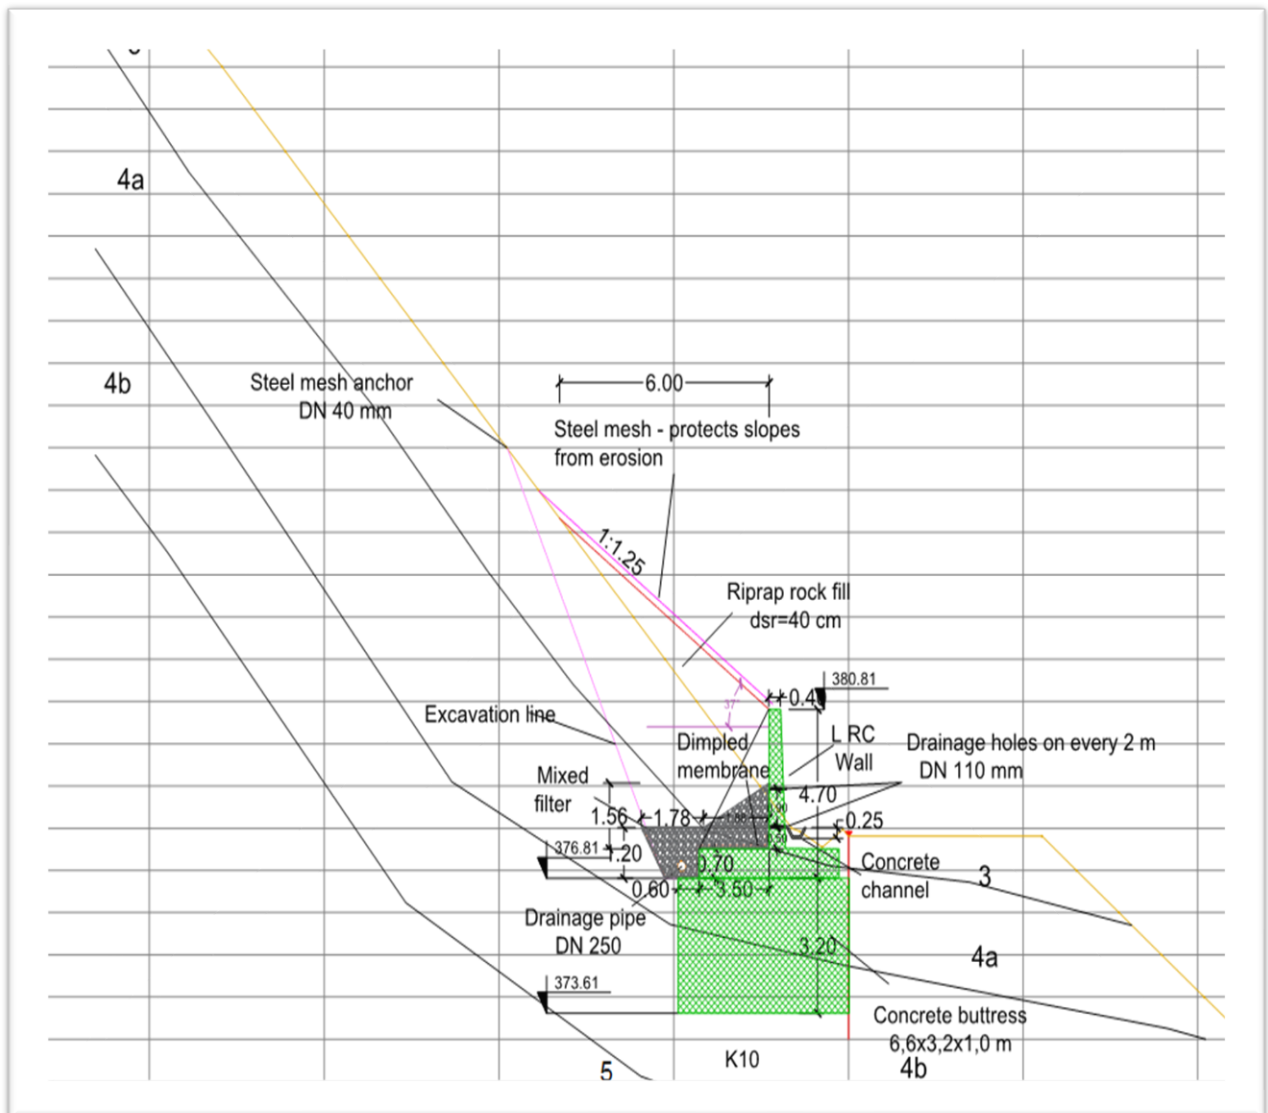
The solutions are shown in Figure 3, showing the normal transverse profile of the remediation.

Figure 4. Normal transverse remediation profile

1. Retaining wall with a length of 51.33 m and height $H=4.70$ m.
2. Construction of drainage and concrete channel. Collected water from the drainage and concrete channel is led down the slope to the nearest recipient (an existing stream) in a full pipe.
3. Placing a stone wall above the retaining wall – securing the slope.
4. Inspection wells – they serve to collect, clean and control groundwater runoff
