GEOTECHNICAL RESEARCHES AND REHABILITATION OF THE LANDSLIDE AT THE BANJA LUKA – ALEKSIĆI MAIN ROAD

Đurić Nedo¹, Santrač Petar²

At Banja Luka – Aleksici main road the landslide occurred due to the inadequate construction works at the slope. The landslide caused the road damage, so the traffic participants safety is endangered. Geotechnical researches are conducted, detailed geological relations in terrain were established, sliding causes defined, depth of moved matters and the Project for rehabilitation is developed, on which basis the rehabilitation was conducted. Results of researches, type and dynamic of rehabilitation measures are shown in the paper.

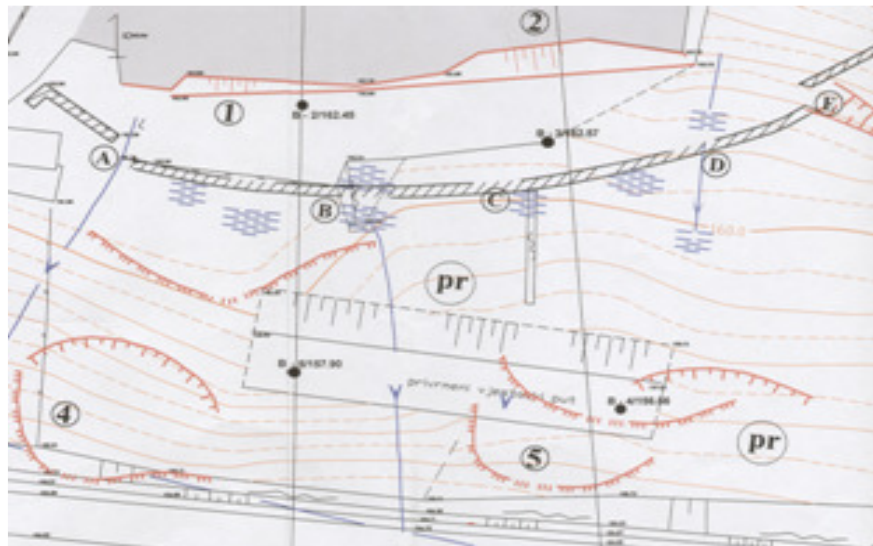
Completing the construction of the support walls which used to connect the edge parts, and the final terrain backfilling represents the second phase of the works. The backfilled material and the support wall are covered by the humus and grass. Few months later, the landslide got activated, covering the surface of around 2 500 m². The sliding depth in the central part is around 6,0 m from the terrain surface, and the mass of around 12 000 m³ is moved, Figure 1. At the landslide surface, the groundwater appeared at the several spots, which was drained by underground drainages.

Slika 1. Prostorni položaj klizišta prije sanacionih mjera
Figure 1 Spatial location of landslide before the rehabilitation measures

In the aim of protecting the main road against the soil mass movements, reducin the buerden of the slope was conducted, by removing earlier backfilled material which started moving. Surface waters were drained to the edge channel, Figure 5, so the
