Review paper

EXAMPLES OF LANDSLIDES IN THE FEDERATION OF BOSNIA AND HERZEGOVINA WITH THE ANALYSIS OF THE CAUSES OF THEIR ACTIVATION

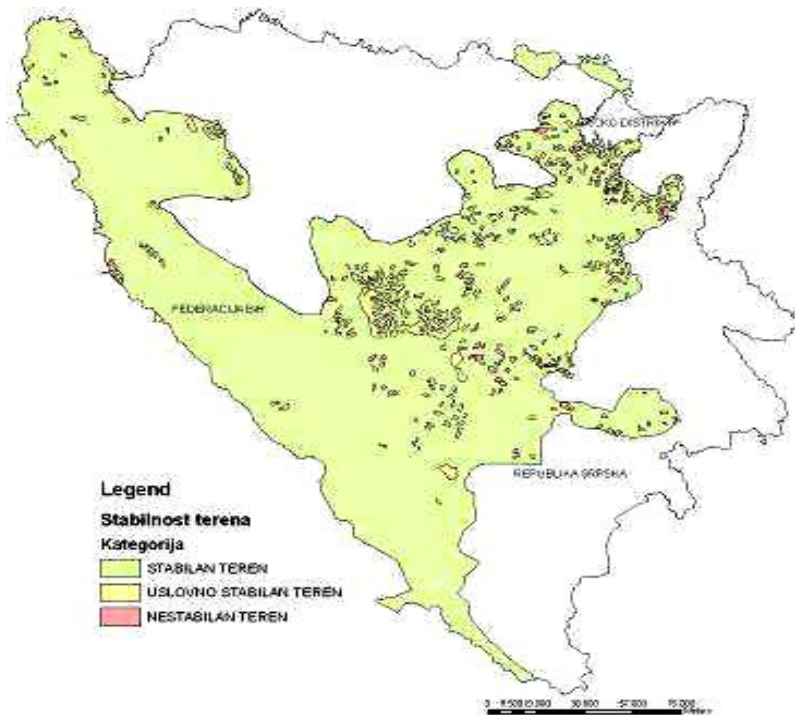
Figure 1 shows the zone of stable, unstable and conditionally stable terrain of the Federation of Bosnia and Herzegovina [1]. That is defined as:

- Unstable terrain, high hazard and conditional probabilities of landslide formation $> 10.67\%$
- Conditionally stable terrain, medium hazard and conditional probabilities of landslide formation $3.56 - 10.67\%$
- Stable terrain, low hazard, conditional probability of landslide formation $< 3.56\%$.

Figure 1 Ground stability in the Federation of Bosnia and Herzegovina

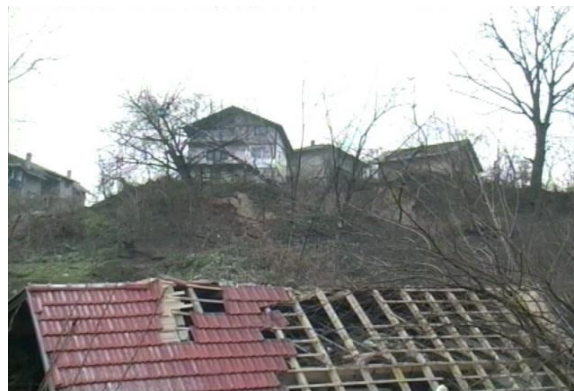
The depth of the landslide is 10-12 meters and is related to the depth of burial clay layer that lies beneath the sand, figure 2.

Figure 2 Landslide "Crvene njive" in Tuzla, Bosnia and Herzegovina.

In the western part of the Tuzla municipality in the district of "Crvene Njive" is a broad cam form built mainly of quartz sand and clay, with the proviso that the sand until 1963. was exploited for the purposes of infilling pit mines Moluhe whose exploitation was completed in 1963. High depression with two high and steep slopes that were left unprotected from impact erosion remained after the exploitation of sand. The wider area is located in an area of Sjeverne krekanske coal serie. After examining the existing geological and engineering-geological documentation it was clear that on this site before activating the escarpment, landslidewas not registered. This area has been for more than 40 years exposed to the effects of exogenous processes, so minor crumbling without major instability happend. In the hinterland of Južna kosina a large number of illegally constructed buildings that don't have governed drain of rainwater and wastewater was built, and also greater quantity of garbage was delayed.

After the geophysical investigations, it was found that a fault is formed in the frontal section. Along unfavorably oriented faults and neotectonic cracks within the massif, separation and breakout of sandstone blocks occured [4].

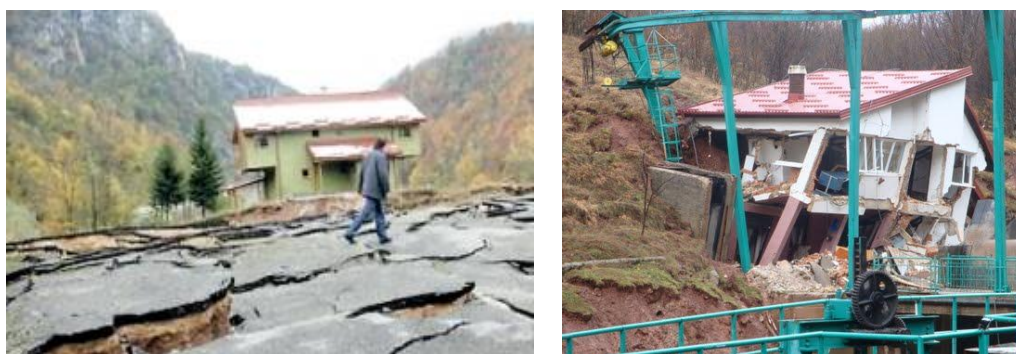
Landslides negatively influence on morphology of surface of area and it can be seen in examples of landslides in Suljaković near Maglaj and Bogatići at Trnovo [5]. One example of impact of landslides on forest vegetation is also landslide in Bogatići at Trnovo, which represents the largest and fastest landslide, figure 3.

Figure 3 Landslide in Bogatići, Municipality Trnovo – Bosnia and Herzegovina

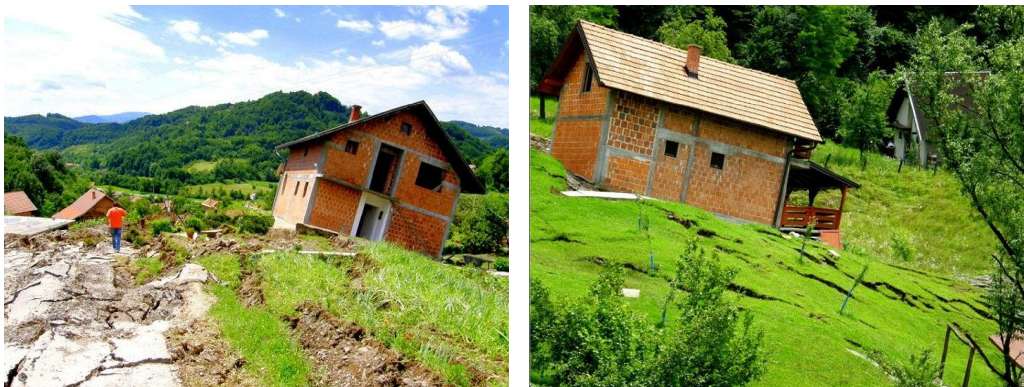
Landslides negatively influence on morphology of surface of area and it can be seen in examples of landslides in Bogatići at Trnovo and also Suljaković near Maglaj [6]. According to the scale and catastrophic consequences, this landslide is one of the largest in BiH. During the construction of the M-17 there was already a landslide, which was then repaired. Landslide is certainly formed after recent rains. During the construction of houses, these were buried streams which are on the left and right sides of landslides. These streams were dragging surface water. Another cause is illegal construction. Cutting the slope at upper side of facilities, including leveling and filling from lower side, resulting imbalance of mass, disturb is natural balance conditions and then worst happens, figure 4.

Figure 4 Demolition of houses in Suljaković, Municipality Maglaj – Bosnia and Herzegovina
