Review paper

SILTATION OF MODRAC HYDROACCUMULATION FROM ASPECT OF USABLE VOLUME

Suljić Nedim¹, Hrnjadović Jasmin¹

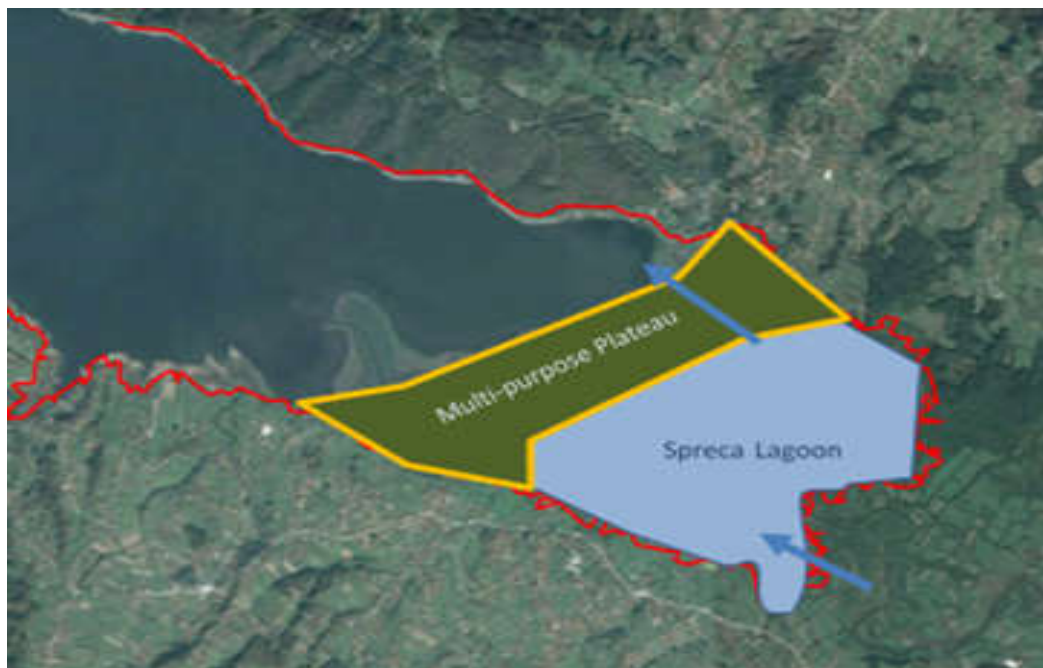
Figure 6. Multipurpose plateau between the lagoon and accumulation – concept of solutions

- a) Removing seven million m³ of sediment from the delta of the Spreča river and the Turija river, by a combination of dry excavation and hydraulic dredging, Figure 5.
- b) After removing the sediment, to form a lagoon separated by dikes from the main body of accumulation. Lagoon will "intercept" sediment transport and thus prevent its entry into the Modrac accumulation, Figure 6.
- c) Use a sediment material for reclamation of exploited mine caves or, more economically feasible, to create a new multi-purpose plateau between planned lagoons and reservoirs for agriculture, tourism or other development needs Figure 7.

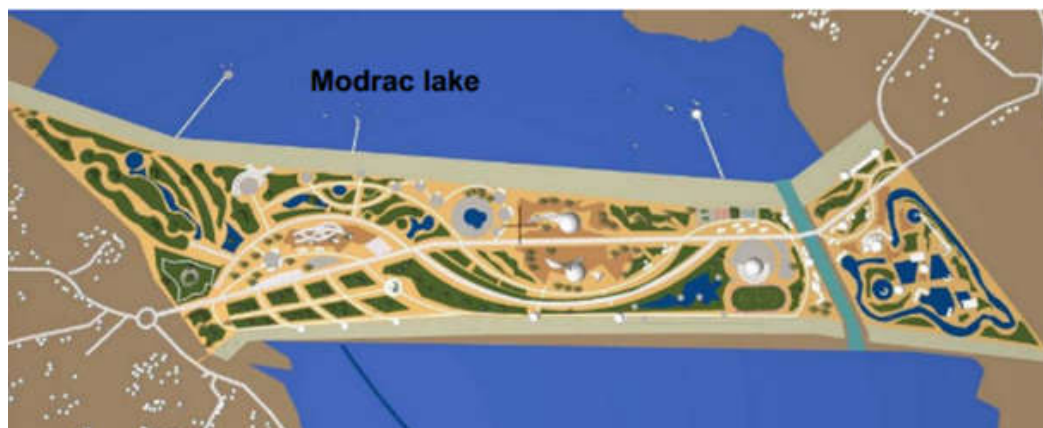
Figure 7. Multipurpose plateau between the lagoon and accumulation for recreational purposes
